The Saga of the Damp 1995 -2009

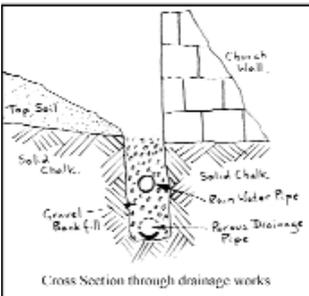
At the start of the Millennium Appeal it was realised that the damp problem on the west and south-west walls of the church had to be one of the priorities for funds as there was beginning to be serious damage to the internal stone work of the reredos and also to the plaster behind the pulpit. It was thought that this was due entirely to rising damp. The first work of the Appeal was to replace the Victorian open brick gully round the west and south walls of the chancel and vestry by a porous land drain sunk deep into the chalk on which the walls are founded. The improvement in the damp to the walls of the chancel was immediate; but the masonry took a considerable time to dry out. The wall behind the pulpit improved, but only very slightly - this was thought to be because of the very considerable thickness of the wall.

The damaged masonry of the reredos was repaired using carefully coloured artificial stone mortar. The repairs were deliberately left slightly less than perfect so that they would not stand out too much against the rest of the stonework (new stone was also rejected for this reason and also for cost considerations). At the same time all the emulsion paint, which incredibly had been applied to all the masonry of the reredos, including the delicate carving, during the 50s, was painstakingly removed. The paint had been a major cause in making the damage so severe as it trapped the damp within the stone.

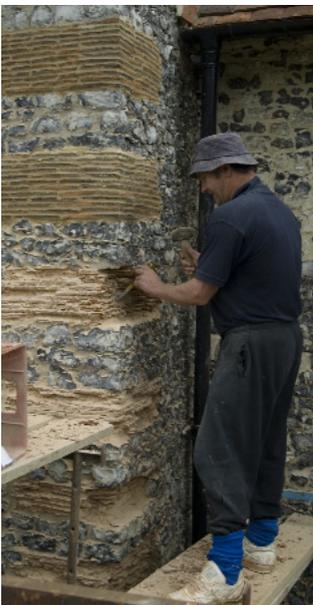
During the Quinquennial Architectural Inspection of the church it was stated that the exterior of the church needed re-pointing in several places including the area adjacent to where the damp had been. During this inspection it was spotted that there were 2 old stumps of trees (probably ash) about 4" in diameter in the surface of the wall - at last it became obvious why the drain overflows had penetrated the wall so readily. These stumps have been removed and the necessary re-pointing with lime-mortar completed. Unfortunately the pieces of timber were not saved so it has not been possible to date or type them. But it is highly probable that they were from the period in the 18th C when the church was reported to be in a poor state.

During the time when the wall was suffering severely from damp the tile-quoins that had been used on the corner of the wall had softened and crumbled - it was decided to cut the damaged tiles out and replace them.
